THE KEYSTONE CHAPTER
of
THE FALCON CLUB OF AMERICA

Newsletter

January, 1990

TECHNICAL SERVICE BULLETIN

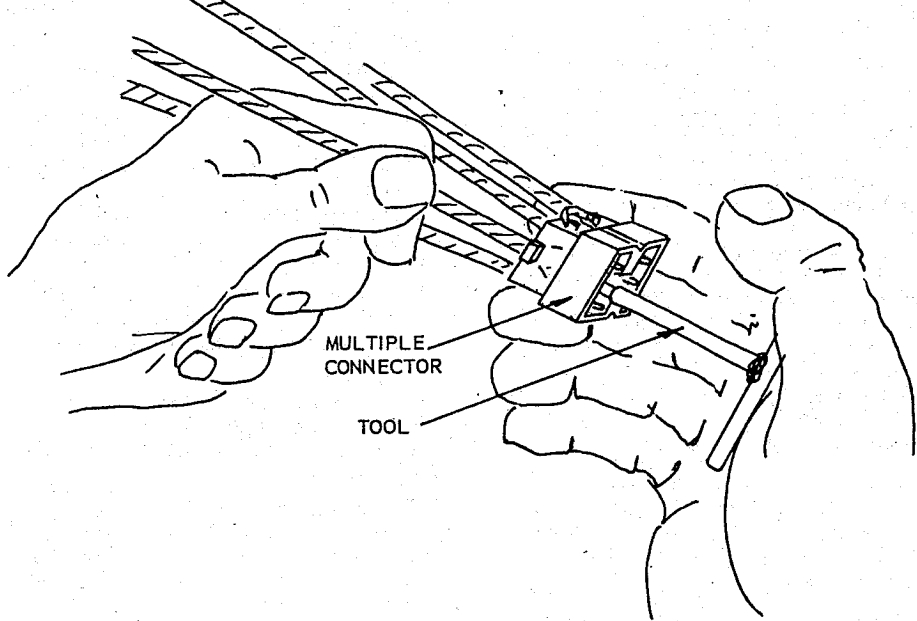
Fig. 18 - (Article 77)

Considerable difficulty may be encountered in the field on all 1965 car lines in removing the bullet terminals from the turn signal switch multiple connector at the lower end of the steering column. As an aid in removing these bullet terminals, two ways of fabricating a tool at the dealer level are shown.

The locking latch at the end of the bullet may become overly compressed in some cases and will not allow the bullet terminal to lock in the connector upon re-installing. When this problem is encountered a knife edge may be used to pry

The tool, as illustrated, is T-shaped for easy gripping in the palm of the hand and can be fabricated with 3/16 in. drill rod stock or 3/16 in. copper tubing. The end of the tool when inserted over the individual bullet terminal to be removed, compresses the locking latch at the end of the bullet and allows the bullet terminal to be pulled away from the multiple connector. (See Figs. 18 thru 21).

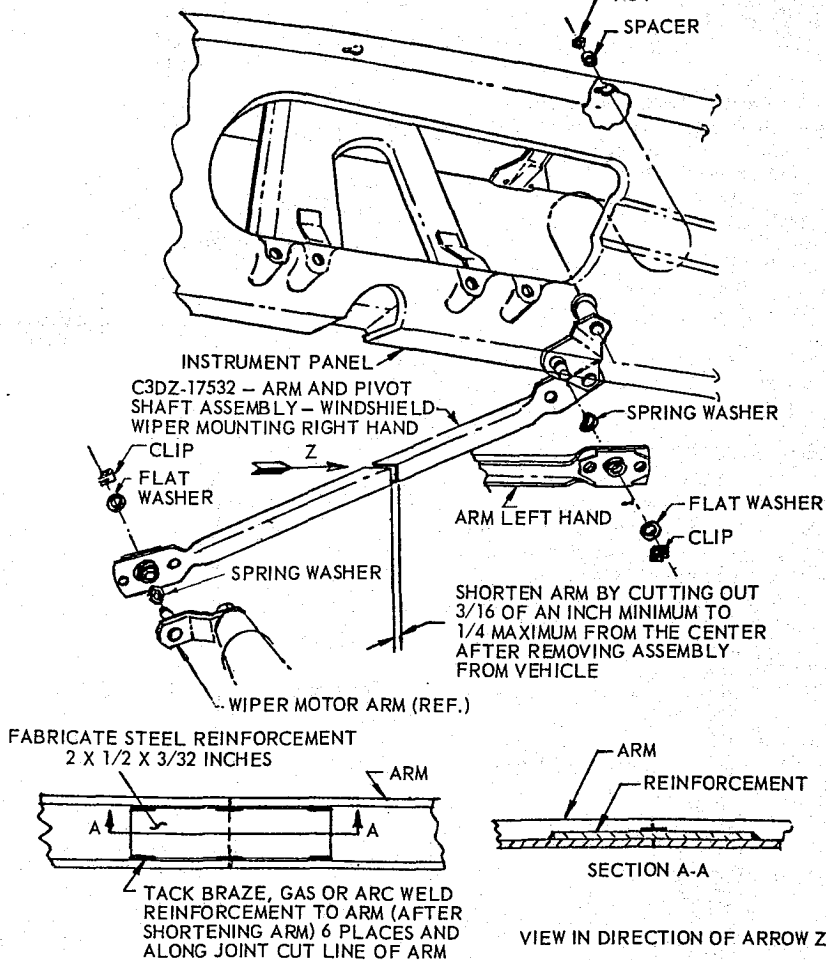
Fig. 16 - Windshield Wiper Linkage Rework - 1964-65 Falcon - (Article 150)

Windshield wiper system chatter or thumping noise is the result of the windshield wiper motor attachment being mislocated thereby causing excessive travel of the right hand arm and pivot assembly until the arm interferes with the pivot.

Should dealers encounter complaints of erratic or thumping windshield wiper operation, the following corrective procedure is recommended:

1. Disengage the right hand windshield wiper mounting arm and pivot shaft assembly (C3DZ-17566) by removing the clip and washer attachments at the motor and at the left arm and pivot assembly.

2. Remove the arm and pivot assembly (right hand) from the vehicle after first removing the wiper blade and attachment nut and spacer.

3. Shorten the right hand arm by cutting out 3/16 of an inch minimum to 1/4 of an inch maximum from the center of the arm assembly.

4. Fabricate a steel reinforcement for the arm 2 x 1/2 x 3/32 inches in size.

5. Tack braze, gas or arc weld the reinforcement to the shortened arm six places and along the joint cut line of the arm.

NOTE: Parallelism and proper alignment must be maintained when joining the cut arm together prior to welding to preclude any possible bind in the system.

6. Reinstall the arm and pivot assembly into the vehicle in reverse order of disassembly.

7. Operate the wiper motor and turn it off to assure that it is in park before installing the wiper arm and blade assembly.

8. Check out wiper system operation.

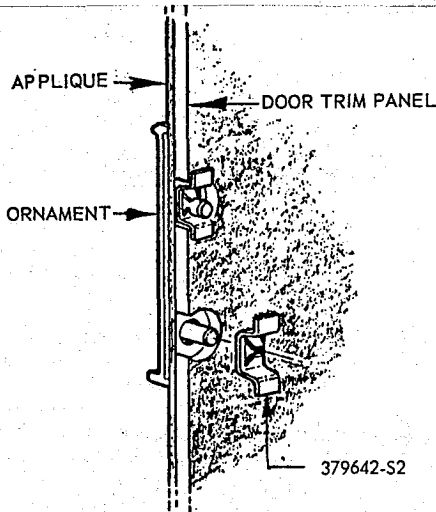
Fig. 16 - Service Fix Ornament Retention - (Article 230)

On some early production vehicles the door trim panel ornaments work loose and/or fall off the front door trim panels. It has been determined that the spring nuts used to attach the ornament do not provide positive retention in all cases.

The caption on Fig. 16 of Article 230, TSB of 3/29/65, should read: "ORIGINAL ORNAMENT RETENTION", instead of "SERVICE FIX ORNAMENT RETENTION".

Dealers encountering vehicles with loose ornaments should remove the front door trim panel to gain access to retaining nuts. It is recommended that new spring nuts (379642-S2) be installed and seated as tight as possible. (See Fig. 16.) In case these spring nuts do not hold sufficiently it is recommended that the trim panel holes be enlarged to 1/2 inch to accommodate palnut (378205-S35) 5/32 self threading nut. Caution should be used to cut these holes so as not to cut into the metal applique panel. (See Fig. 17.)
