THE KEYSTONE CHAPTER
of
THE FALCON CLUB OF AMERICA

Newsletter

January, 1991

THE FALCON AUTOMOBILE

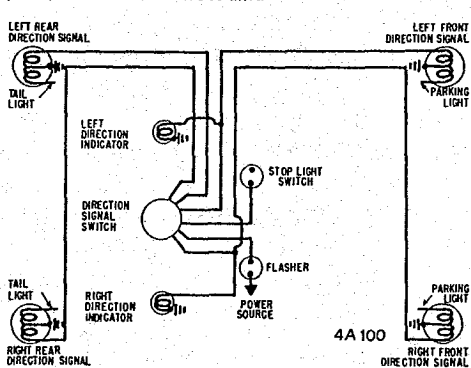
DOUBLE "PARALLEL" TYPE INDICATORS

FLASHER & BULB REPLACEMENT CAUTIONS: 1) If 2 bulbs per side of car (1 front, 1 rear) flash during turn signal operation, "2 Bulb" flasher is required. If 3 bulbs per side of car (1 front, 2 rear) are used, "3 Bulb" flasher is required. Be sure to install correct type flasher according to number of bulbs in system or inoperative system, shortened bulb life, and rapid flashing rate will result. NOTE - Some manufacturers recommend use of "series" type flashers only. Do not use "magnetic" type.

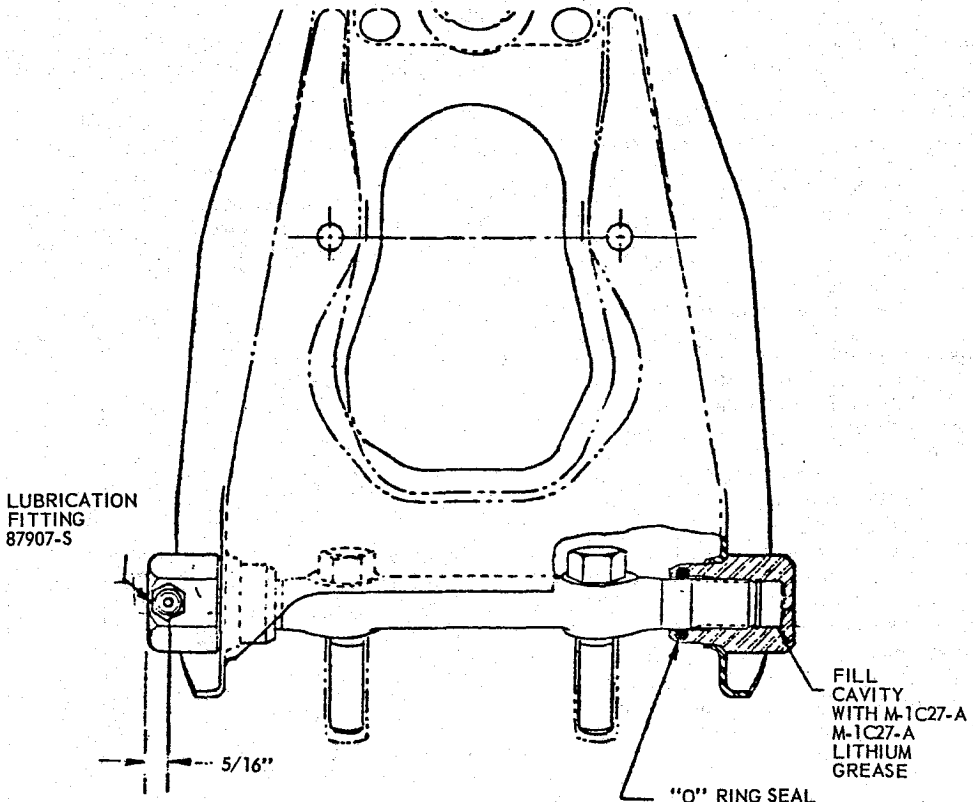
9. Use a hand type grease gun to fill the bushing cavities with long life lubricant. Apply only enough grease pressure to fill the bushing cavities without causing damage to the bushing "O" ring seal.

7. Use a 1/4-28 NF starting tap to thread the No. 5 hole. Use precautions in Step 5 to keep metal chips from entering the bushing cavity.

8. Install an 87907-A (1/4-28) straight lubricator fitting in the tapped hole.

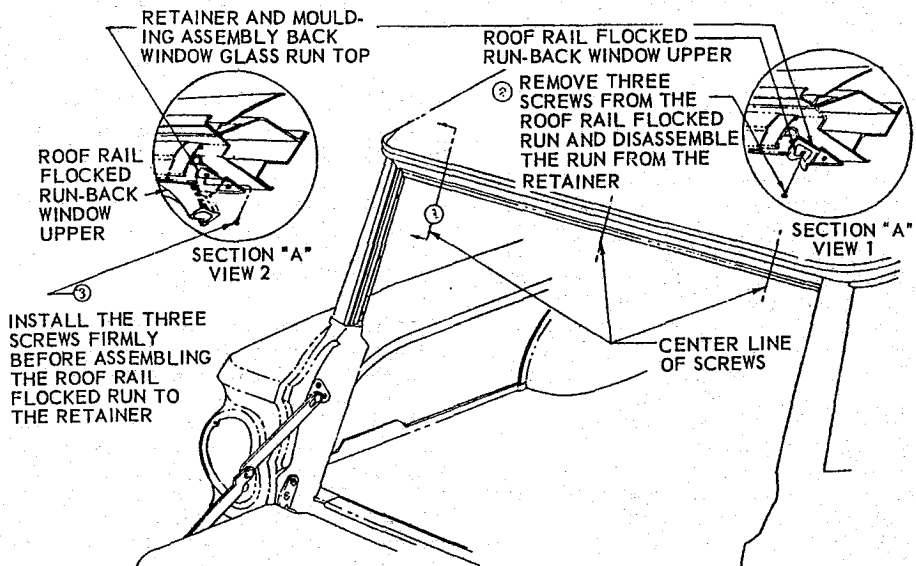
Fig. 13 - Tailgate Glass Breaks in the "Up" Position 1964 and 1965 Falcon - (Article 337)

This problem was corrected in production on February 1, 1965 installing the screws directly to the moulding, under the flocked run. (See Fig. 13.)

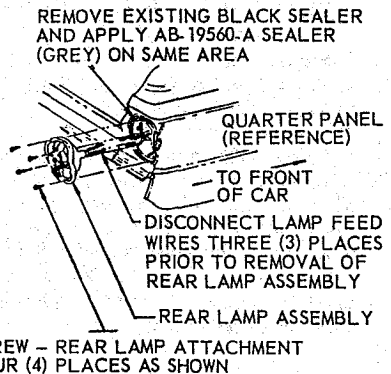
Fig. 5 - Rear Lamp Sealer Stains - 1964-65 Falcon - All Models (Article 239)

If complaints are encountered in the field, the rear lamps should be removed and the black sealer replaced. Reinstall the lamp using AB-19560-A sealer (gray) as required to provide an adequate sealing surface. (See Fig. 5.)

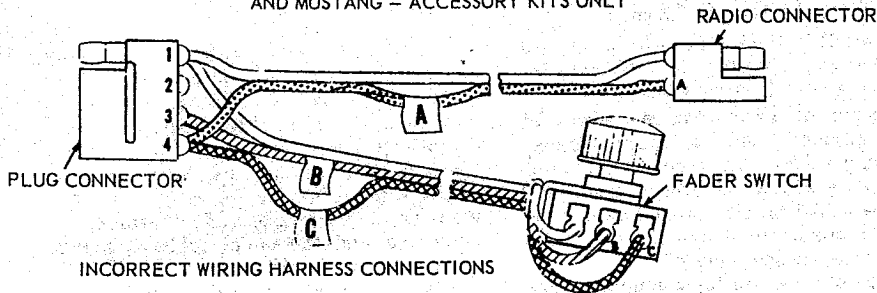
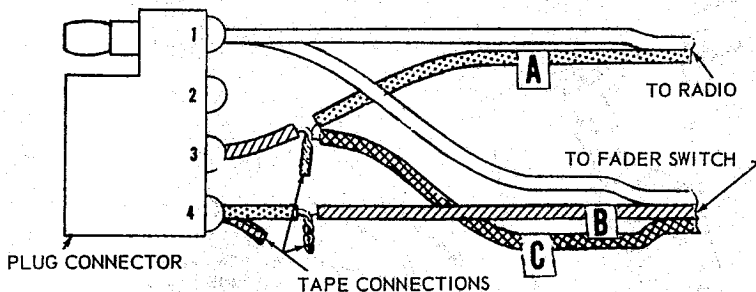
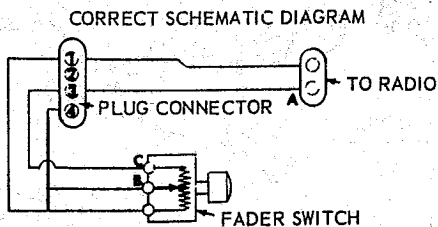
TO CORRECT WIRING HARNESS CONNECTIONS -
MOVE WIRE "A" FROM TERMINAL "4" TO TERMINAL "3"
MOVE WIRE "B" FROM TERMINAL "3" TO TERMINAL "4"
MOVE WIRE "C" FROM TERMINAL "4" TO TERMINAL "3"

Fig. 1 - Rear Seat Speaker Wiring Harness - 1965 Ford, Falcon, Fairlane, Thunderbird And Mustang - (Article 258)

1. Disconnect the wiring harness from the radio, the switch bracket and the plug connector and remove the wiring from the vehicle. Refer to Fig. 1 for wire modifications.

5. Check the revised wiring harness against the schematic drawing to be sure they agree. See Fig. 1.
