THE KEYSTONE CHAPTER
of
The *Falcon* Club of America

Newsletter

January, 1995

DEDICATED TO PRESERVING
THE *FALCON* AUTOMOBILE

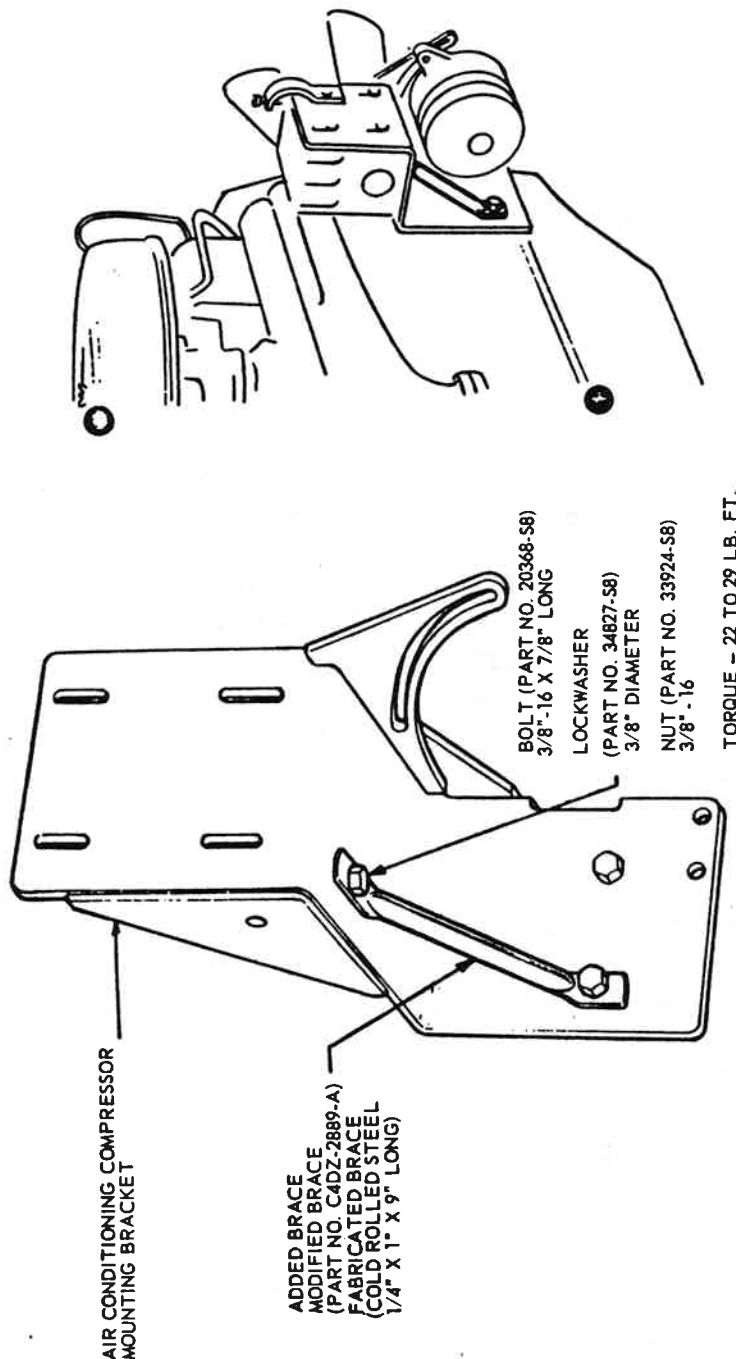
Fig. 2 - 6-Cylinder With Air Conditioning Moan And Vibration Periods Due To Insufficient Compressor Support. - (Article 363)

Field service experience reveals that at 30-38MPH the subject vehicles equipped with A/C may exhibit a vibration and/or moan condition. When normal torquing of mounting bracket bolts and belt tensioning have not corrected the condition, an additional brace at the bottom of the A/C compressor mounting bracket will reduce or eliminate the vibration and/or moan condition.

1. The added brace is to fit between the lower rearward A/C compressor bracket mounting bolt and run diagonally up to the rear outer bottom of the bracket. The brace may be made by modifying a current Falcon compressor lower brace, Part No. C4DZ-2889-A, or fabricating it from a piece of cold rolled steel, $\frac{1}{4}$ x 1 x 9 inches long (See Fig. 2).

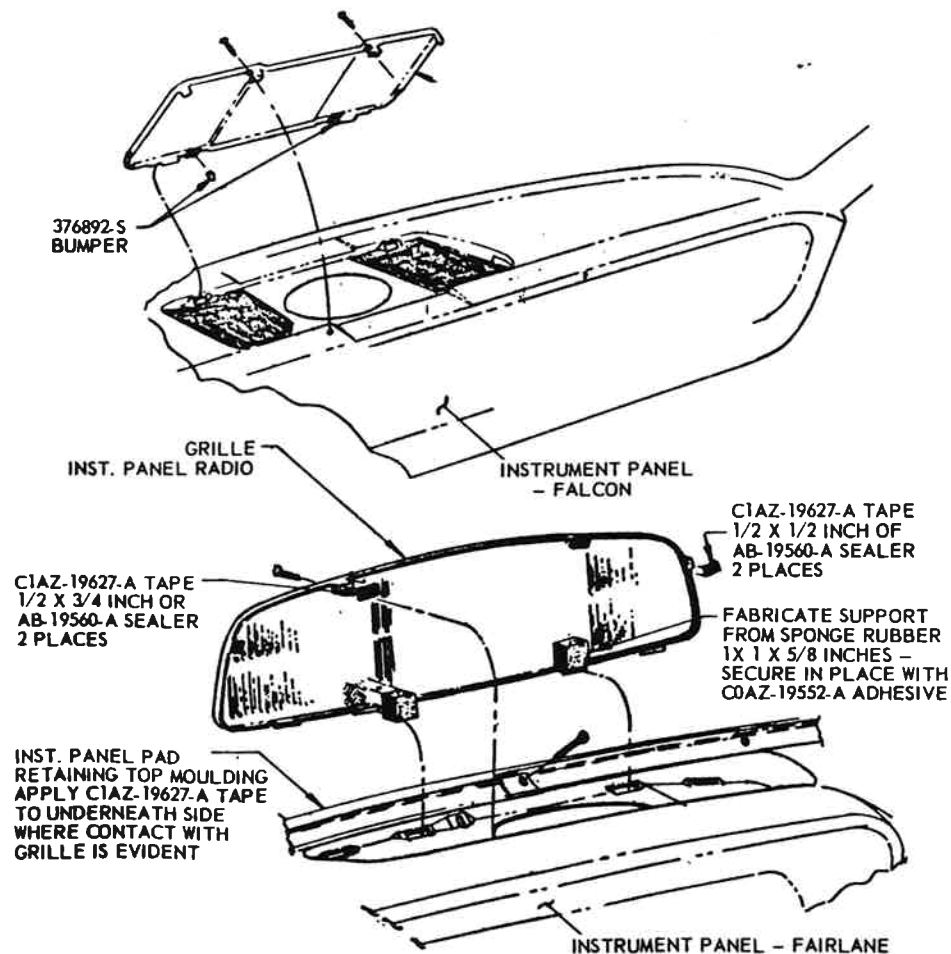
Fig. 12 - Procedure to Correct Rattles Emanating from the Instrument Panel - 1964-65 Falcon-Fairlane - (Article 336)

1. Remove the instrument panel radio grille and attaching screws. If the grille bumpers, Part No. 376892-S are found omitted or out of position, install the bumpers as required. If the support is missing on the Fairlane grille, fabricate

a new support from sponge rubber 1 x 1 x 5/8 inches and secure in place with COAZ-19552-A adhesive. (See Fig. 12.)
